City of Ashland Vaughn Public Library

Facility Assessment – Phase II Building Systems

March 13, 2019

Facility Assessment Report (Phase II Building Systems)

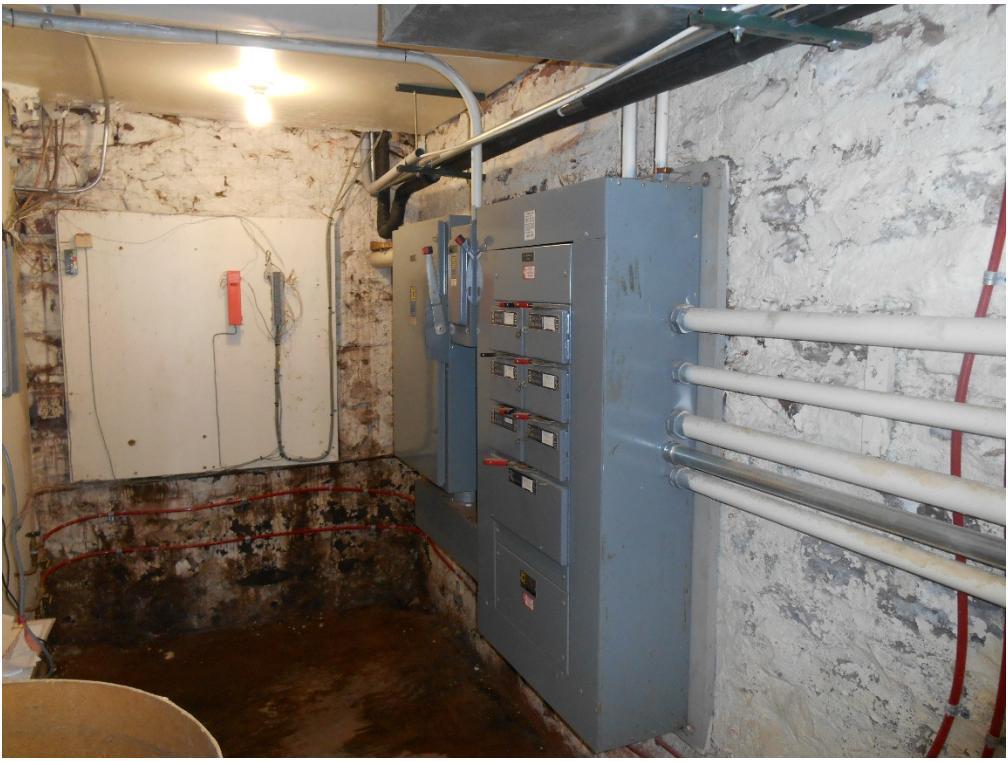
Electrical Service

The existing service is a 600 Ampere 120/208V three-phase system. Power to the premises is provided overhead from Xcel on the south side of the building. Current transformers owned by Xcel are mounted directly on the building and not installed in a typical CT cabinet.

A 600 Ampere fused service disconnect switch manufactured by Square D is located in the basement electrical room. A 600 Ampere Square D QMB fused main distribution panel is also located in the basement electrical room. Five panelboards and the elevator are fed from this main distribution panel. Branch panelboards are Square D NQOB with the exception of a newer panel "A1" which is a Square D NQ panelboard.

A separate 60 Ampere service disconnect feeds an emergency lighting panel "EM". All electrical distribution equipment with the exception of panel "A1" are past their life expectancy and parts may be difficult to obtain.

- All electrical equipment is beyond its life expectancy and is recommended to be replaced.
- A larger service may be required if additional cooling were to be added to the building, or if the usage of the building changes.

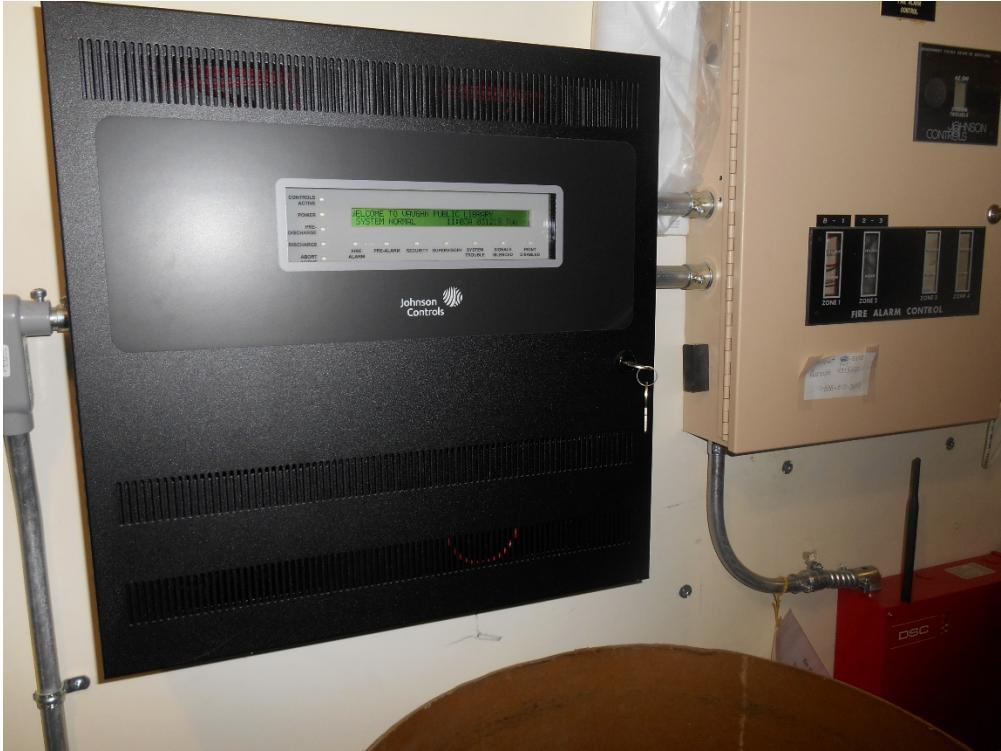
Fire Alarm Control Panel

- The fire alarm system is a combination of a new fire alarm control panel and vintage devices. It is recommended that new initiating and annunciating devices be installed along with a new fire alarm annunciating panel. Additional devices will be required to meet current Code.

- Fire alarm is not currently installed in conduit. Although not required by Code, it is recommended that the fire alarm system be installed in conduit for a more robust system.

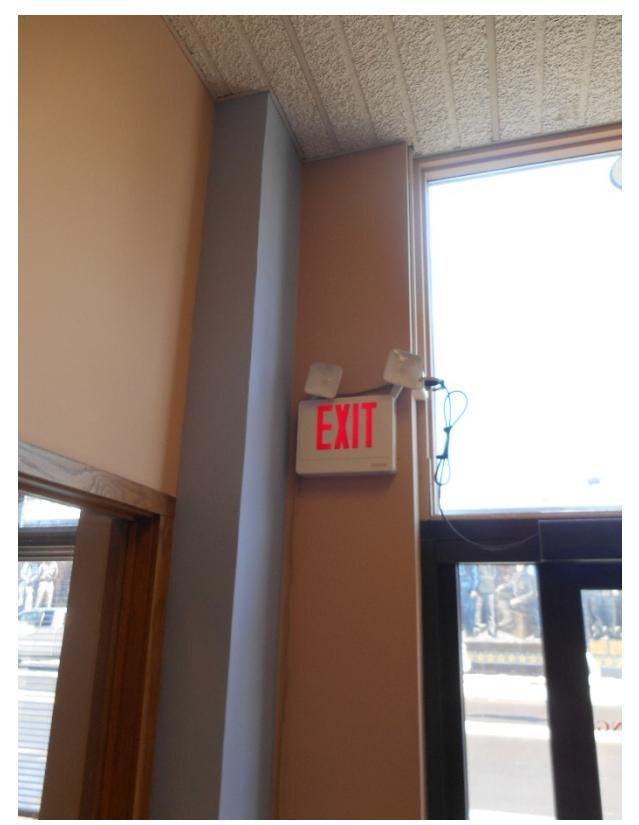
Typical Exit – EM Light

Emergency egress lighting is provided with combination exit sign and emergency lighting unit, stand-alone emergency lighting units, and remote lighting heads. Materials are a combination of new and old. Exterior emergency egress lighting is not provided on this building.

The existing lighting and emergency lighting in the building are beyond their life expectancy. Lighting controls do not meet current energy Code.

- New interior and exterior egress lighting are recommended throughout.
- If fire protection is provided to the building, the disconnect serving the elevator will have to be replaced with a shunt-trip type disconnect.

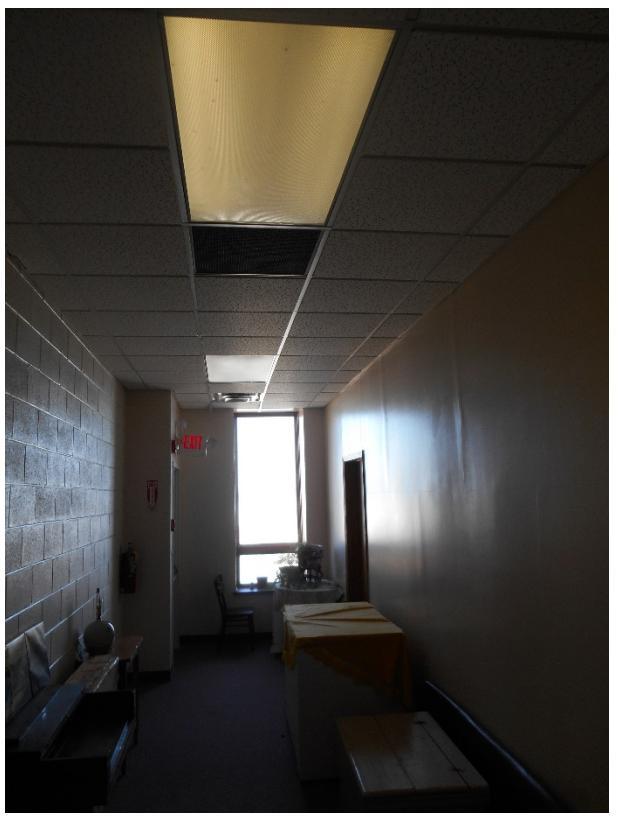
Typical Lighting

The majority of interior lighting is comprised of 2'x4' fluorescent troffers with (4) T-8 lamps and acrylic lens.

- Lighting and lighting controls throughout the building do not meet the current International Energy Conservation Code. It is recommended that new LED lighting and Code compliant lighting controls be installed.

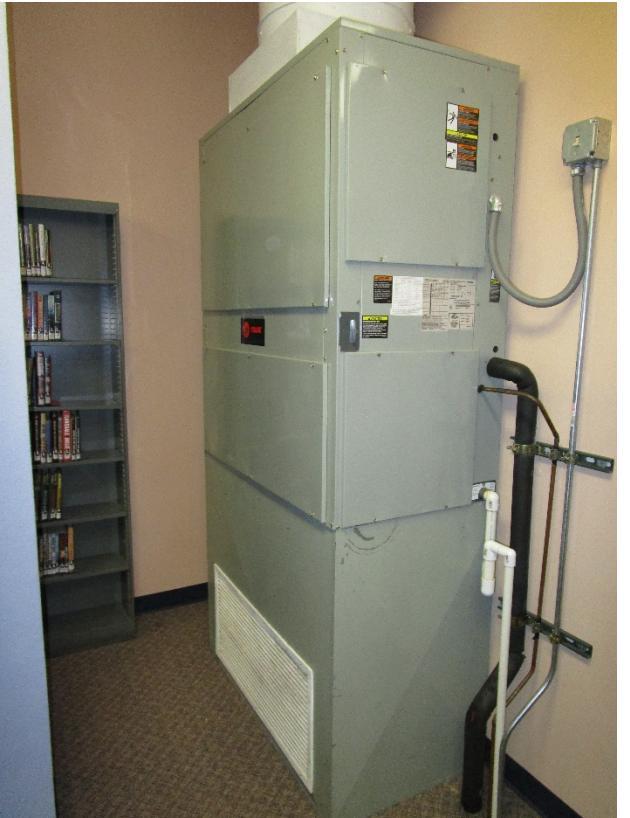
Library Cooling Area (North)

- The cooling condensate from the large AHU in the library is piped to the 8" roof leader without any trap or check valve. This has likely been installed for 15+ years without any issues, but there is potential that water could back up in the roof leader and backflow into the condensate drain.

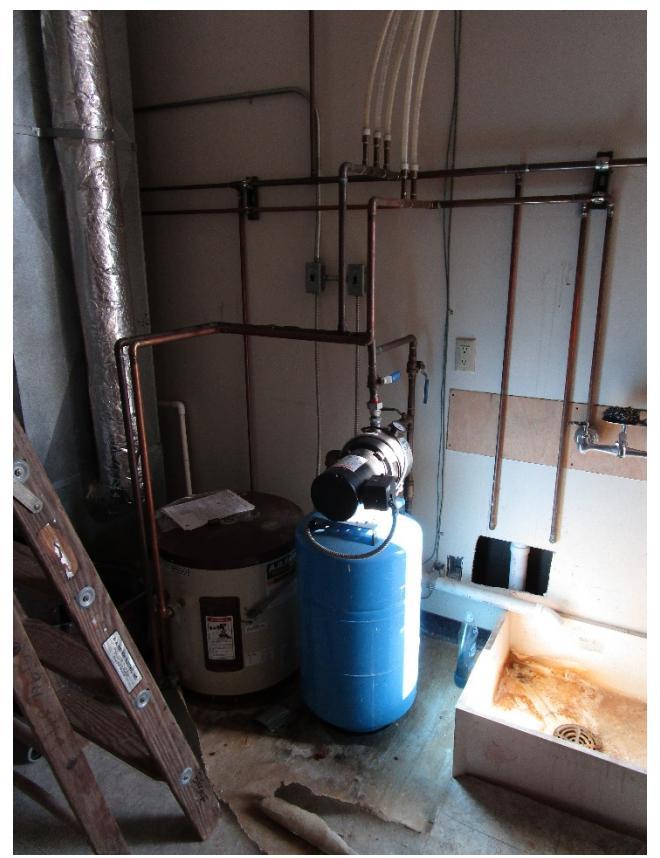
Third Floor Water Heater and Pressure Booster

Electric water heater located on the third floor is 23 years old, which is past its expected life expectancy.

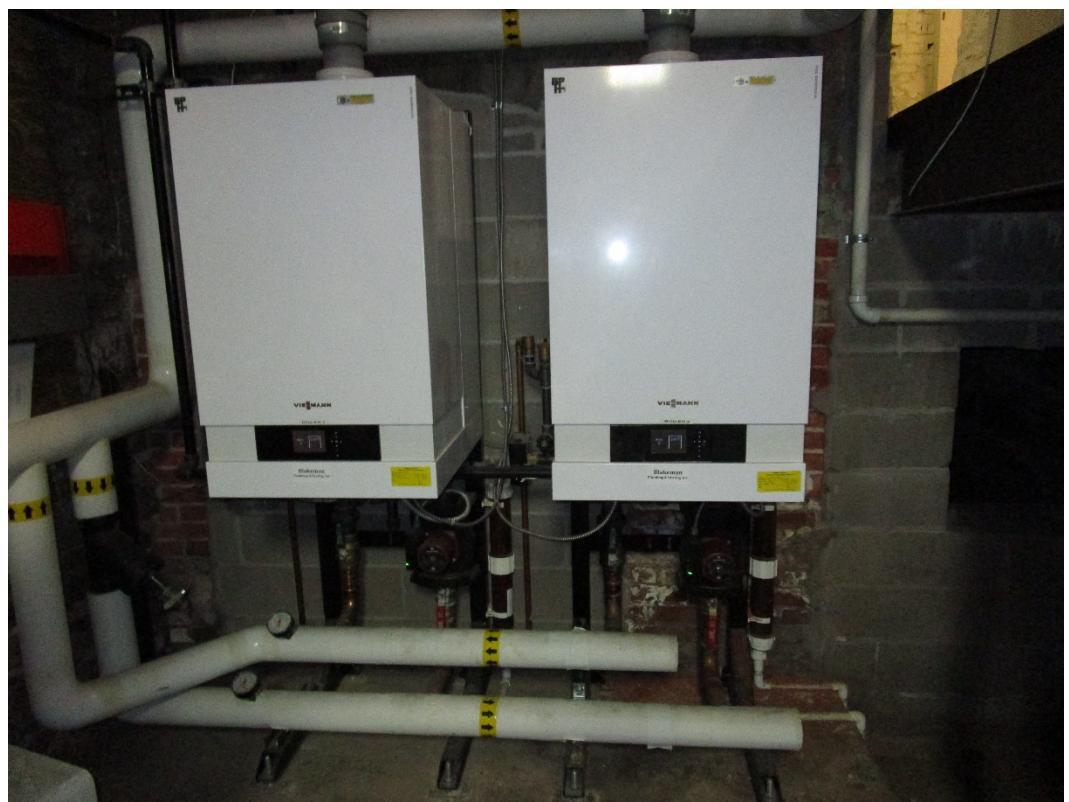
Hot Water Boilers

- Combustion (outside) air is not connected directly to boilers. This is not a code issue, but cold air dumping into the boiler room can cause unnecessary issues like a cold boiler room or frozen water pipes.

- The boiler room is required to be fire rated because each boiler is over the 399,000 BTUH threshold determined by code. The current construction of the room should allow for this, however, there are numerous openings and penetrations that are not protected as required.

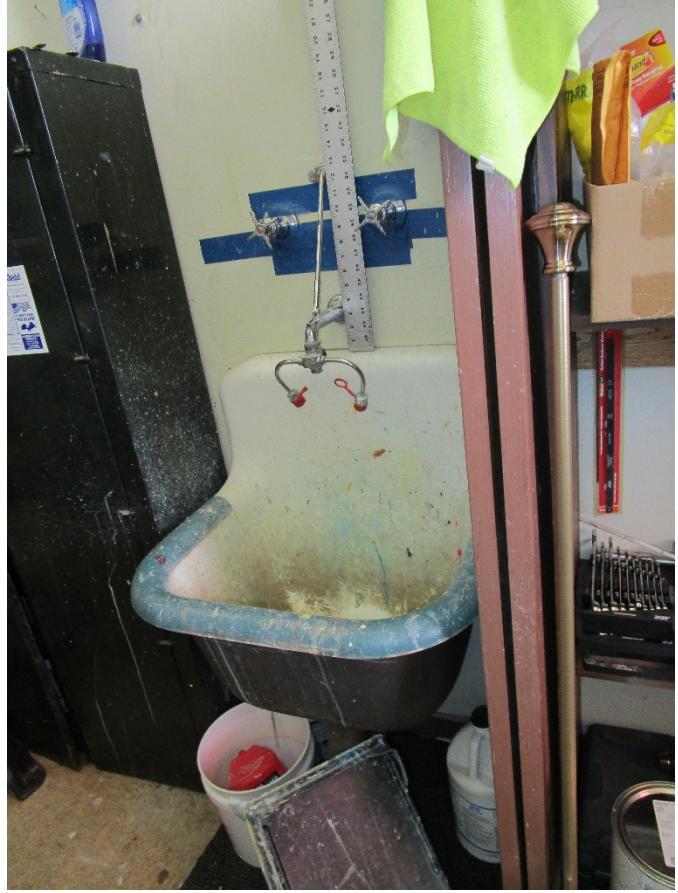
Janitor Sink with Eye Wash

- The eyewash spray heads are pointing down. The heads should be pointing up to be effective. The operation of the eyewash, per ANSI standards, is to be one movement operation to activate eyewash, and shall be a push or pull motion to activate.
- The mop sink on the third floor is being used to receive condensate from the furnace. The mop sink is not a code approved receptor for condensate.

- Correct ADA guideline related deficiencies.
- Correct Code related deficiencies.
- Insulate water piping to conserve water usage for hot water.
- Provide new eyewash near janitorial sink.
- Correct electrical connection to electric water cooler.

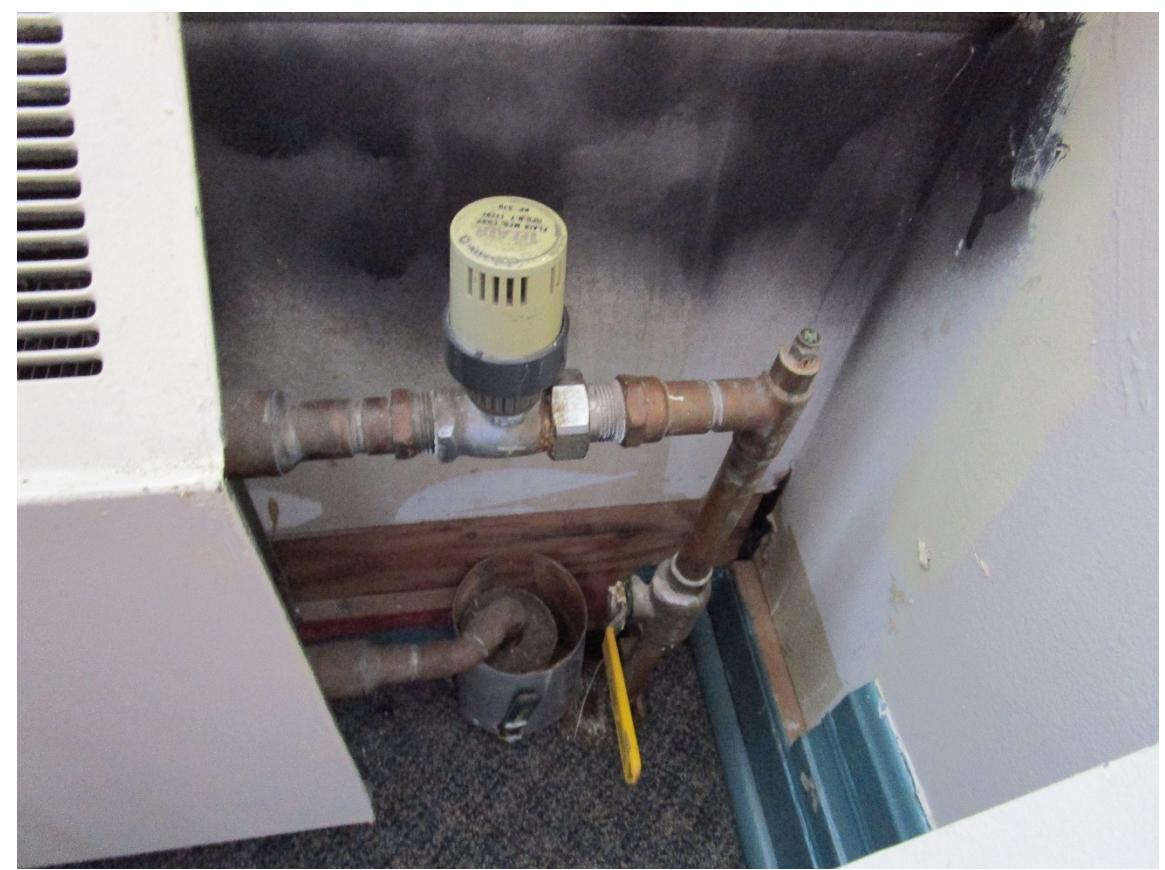
Typical Self-Contained Control Valve

- The majority of the controls are self-contained or standalone electric. This can lead to an increase in building energy use due to lack of temperature control, night setback, and system monitoring. In addition, there are no controls for automatic switchover between heating and cooling.
- A majority of the spaces have high ceilings. This can create stratification where the air near the ceiling is quite a bit warmer than the air at the floor or occupiable space, which leads to higher energy use, lower ventilation effectiveness, and comfort issues.

All HVAC equipment is near or past its life expectancy except the recently replaced boiler system and Daikin condensing unit. This includes a majority of the temperature controls and self-contained control valves.
