City of Ashland Vaughn Public Library

Facility Structural Assessment

January 8, 2019

Facility Assessment Report (Phase I Structural Assessment)

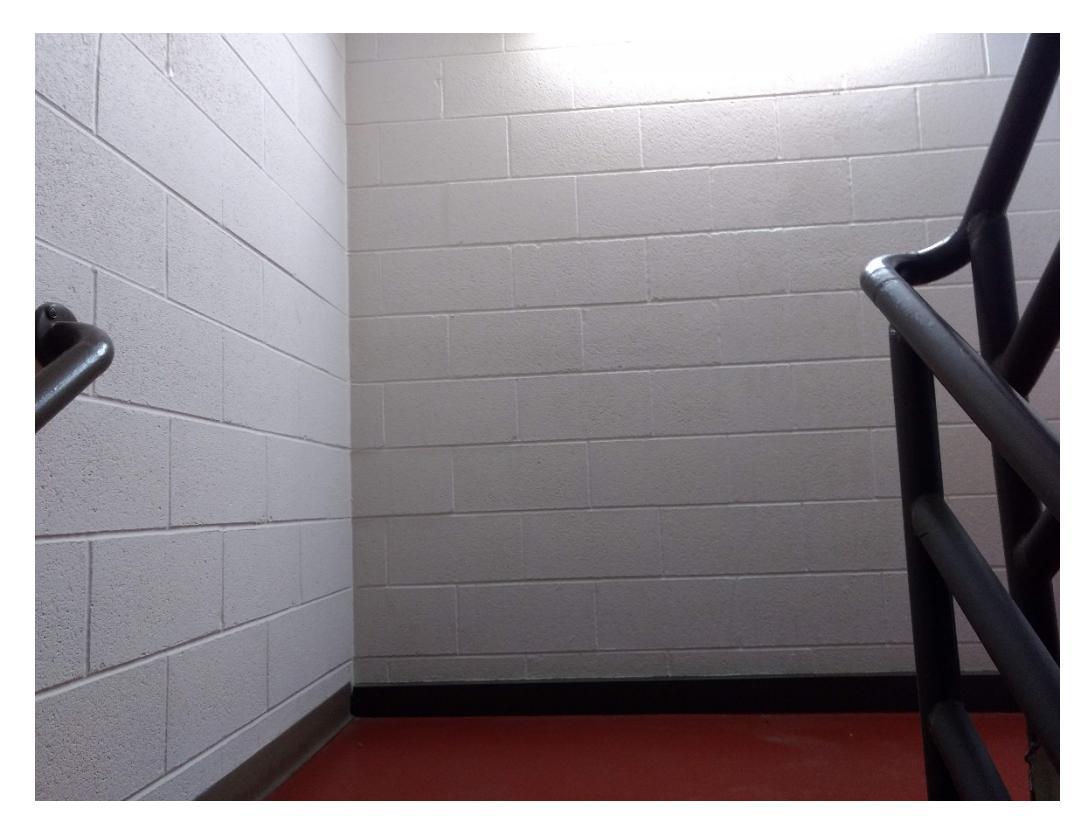
Masonry Stair Shafts, Good Condition

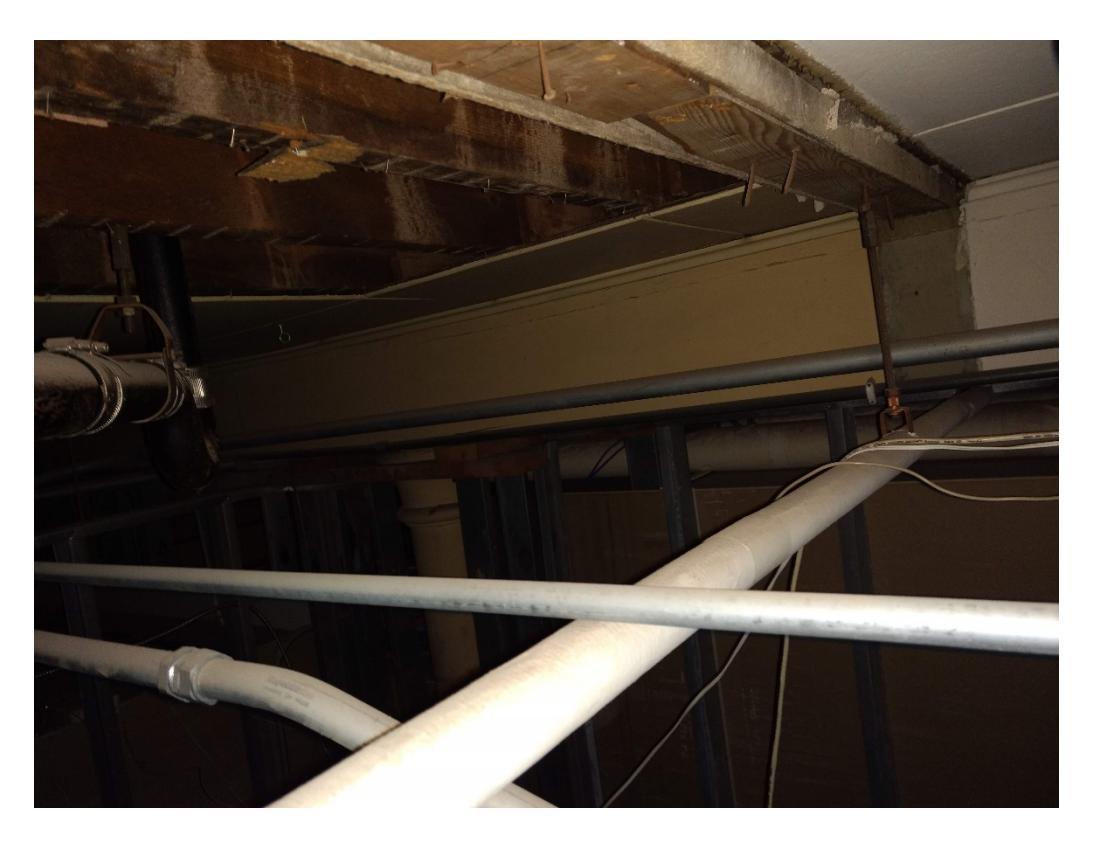
The overall condition of the first floor system appears to be good with the exception of some sagging of the beams. It appears that there may have been some differential settlement of the interior columns. Usually this settlement occurs during the early life of the structure. Over time this condition tends to stabilize.

1st Floor Beam for 2nd Floor

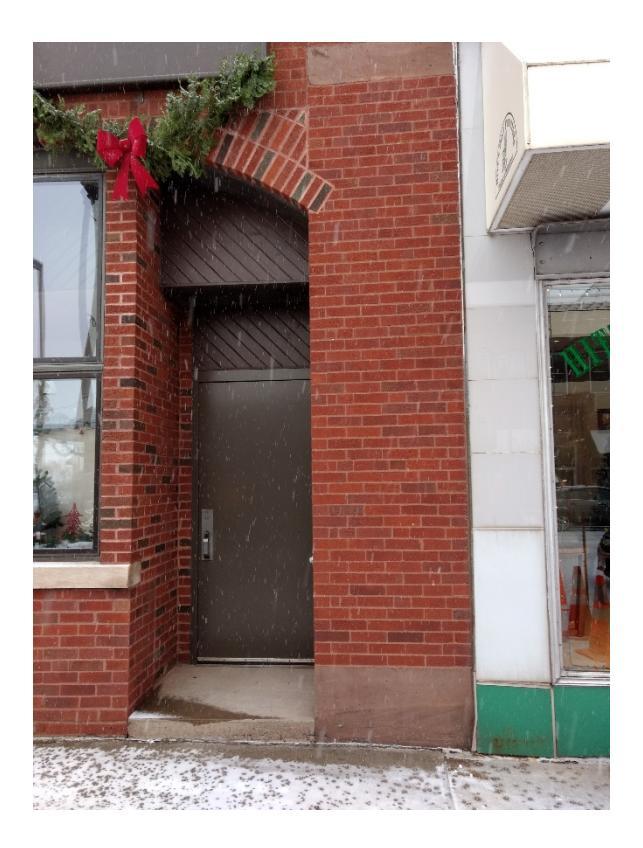
The north wall is in good condition with some deteriorated brick on the upper parapet. There are some vertical cracks above the window arches.

North Wall Parapet

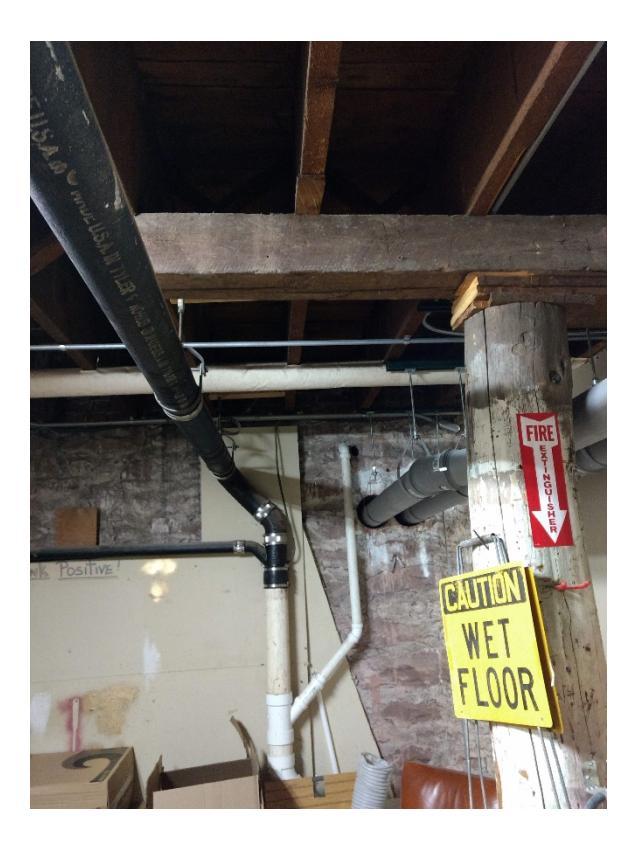
Basement (Previous Repairs)

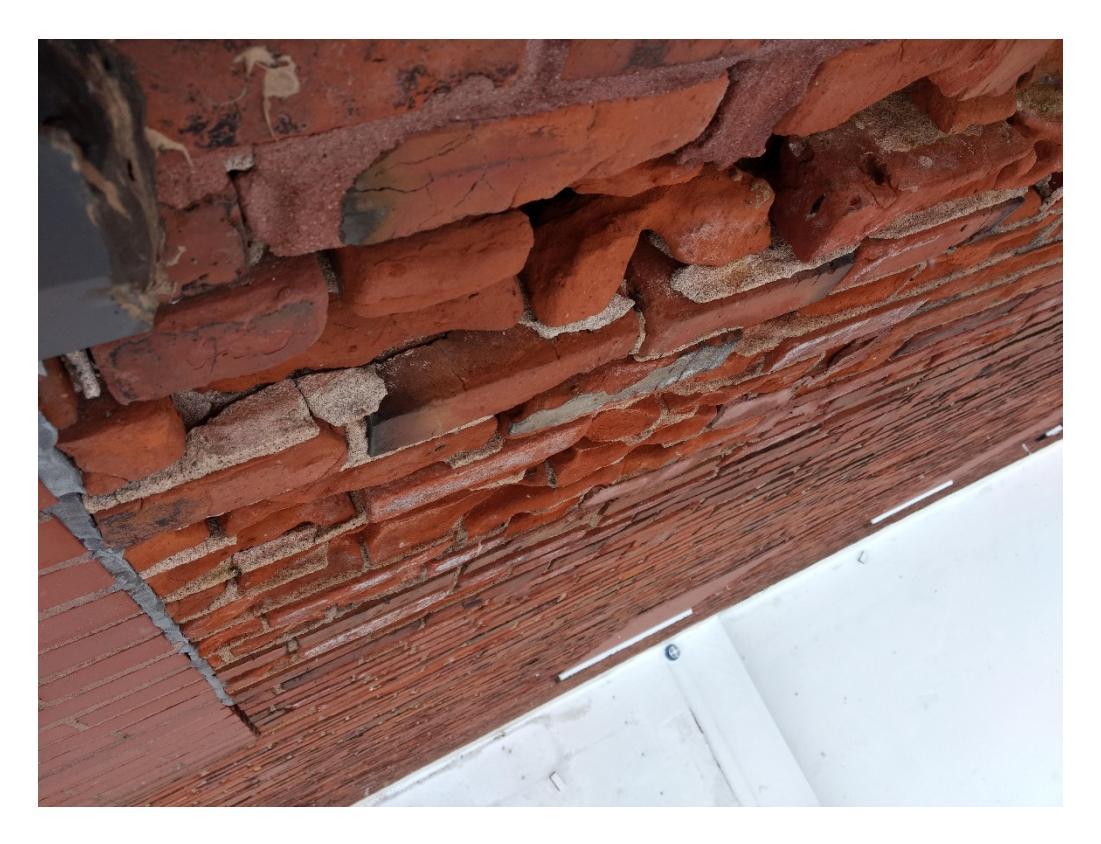
The west wall of the building is in fair condition. There is a chimney near the center of the wall that either needs to be rebuilt or removed due to the deterioration of the brick and mortar. There is a fair portion of the brick that exhibits decay to the exterior brick (hollowing out at the face). This face would require the most attention and substantial tuck pointing.

Chimney Deterioration

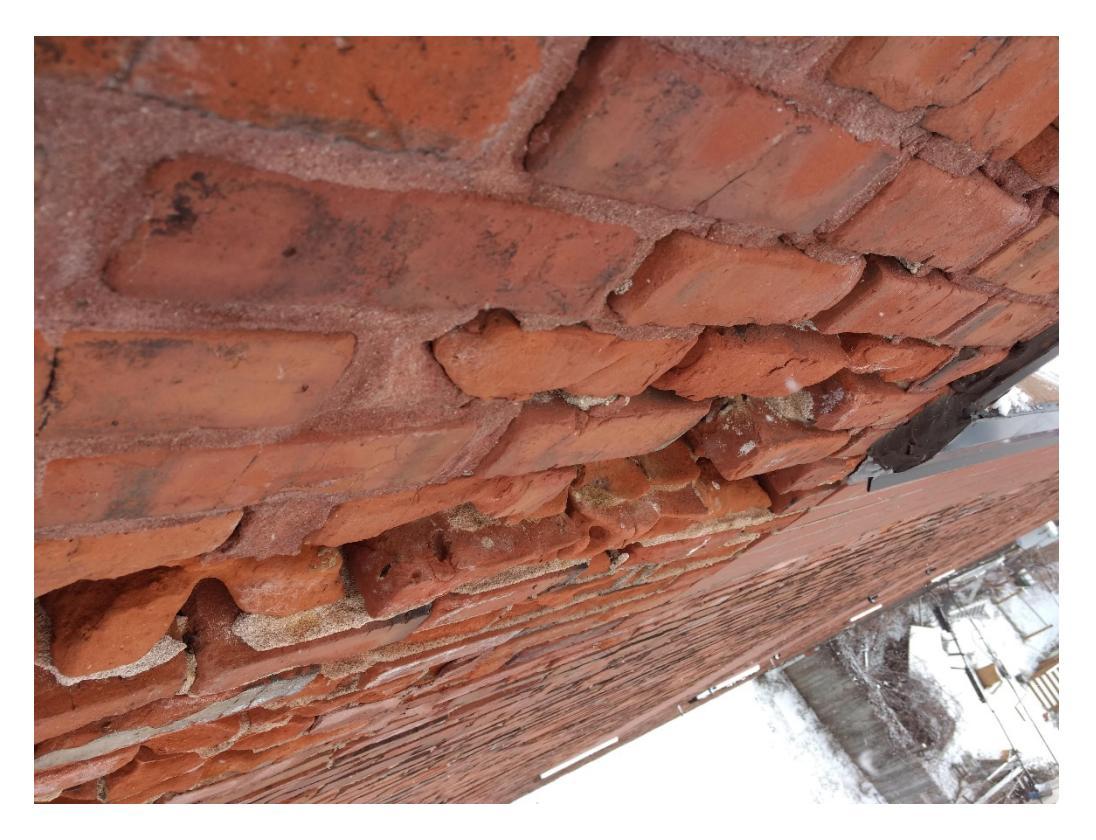
Chimney Deterioration

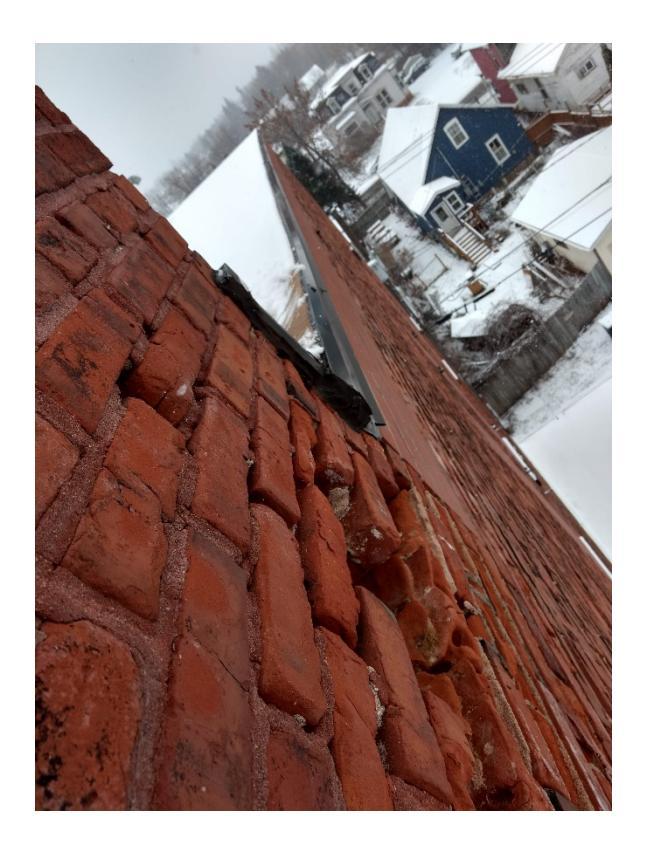
Chimney Deterioration

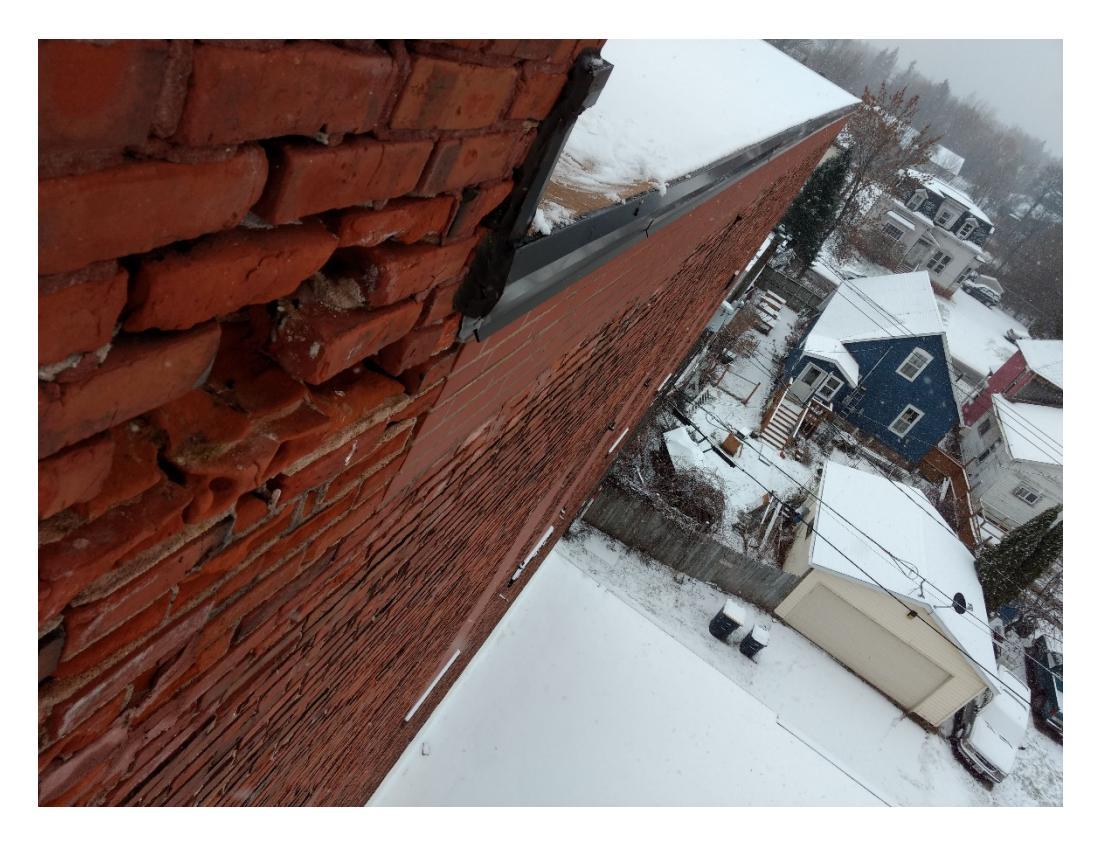
Chimney Deterioration

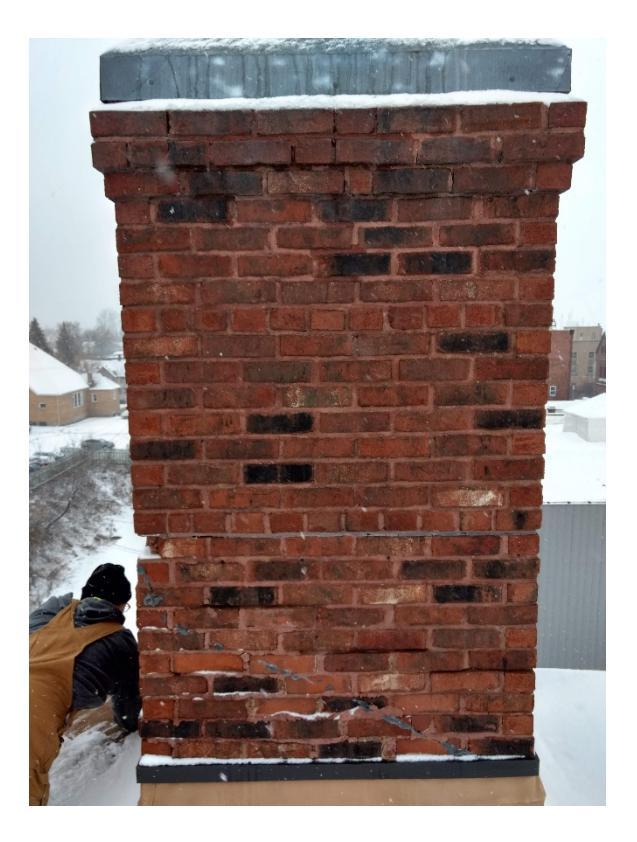
Chimney Deterioration

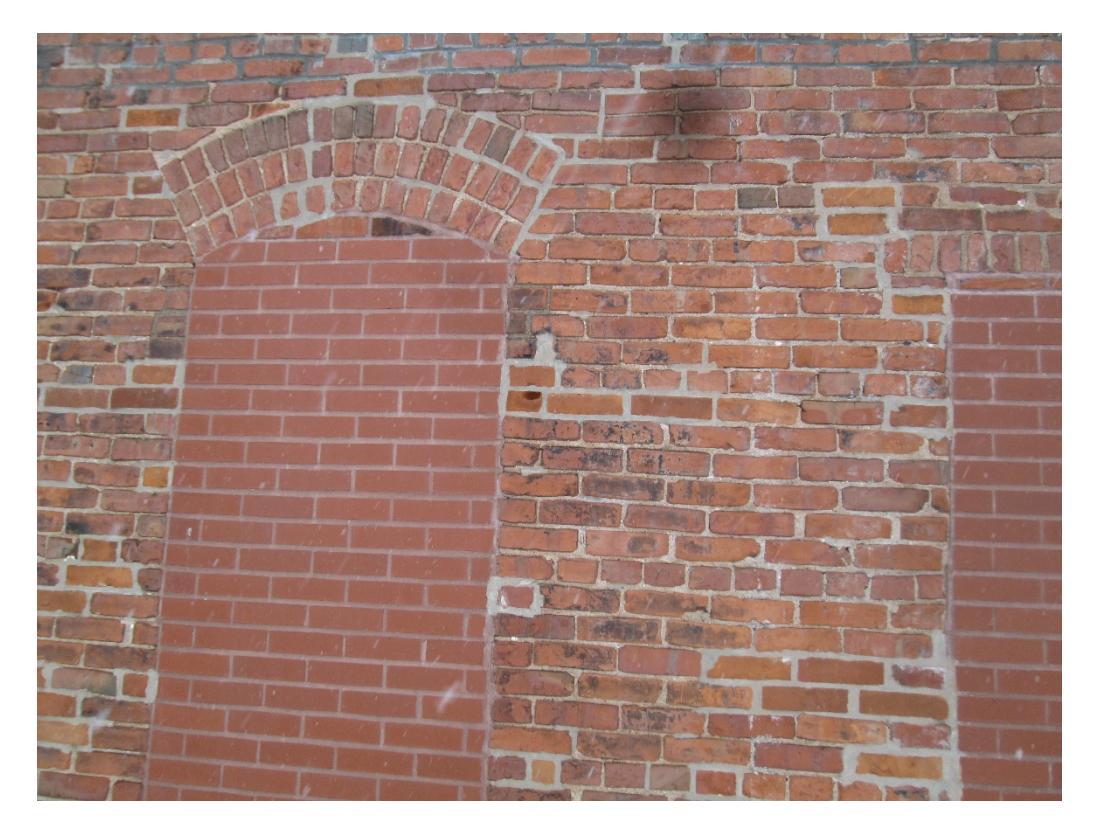
The south wall is in fair condition. It was noted that there is a different brick on the upper 5 to 8-feet of the wall that was recently tuck pointed.

South Wall Patching

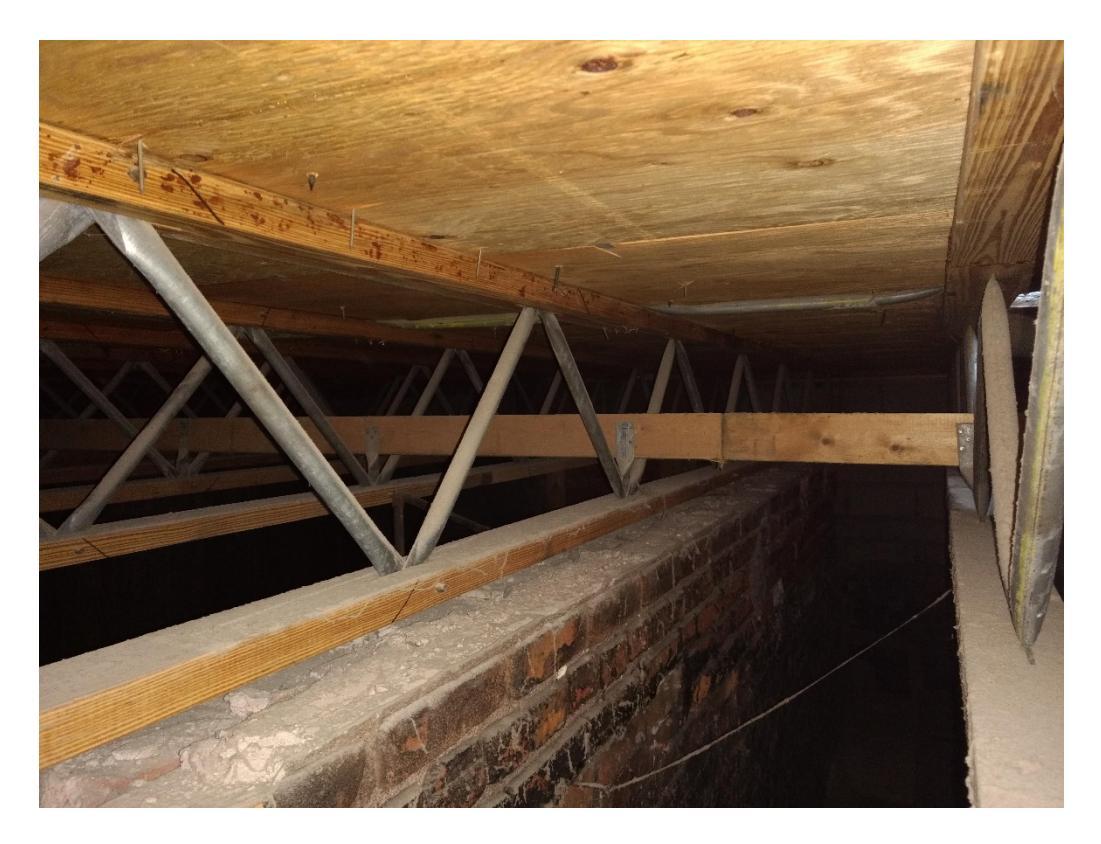
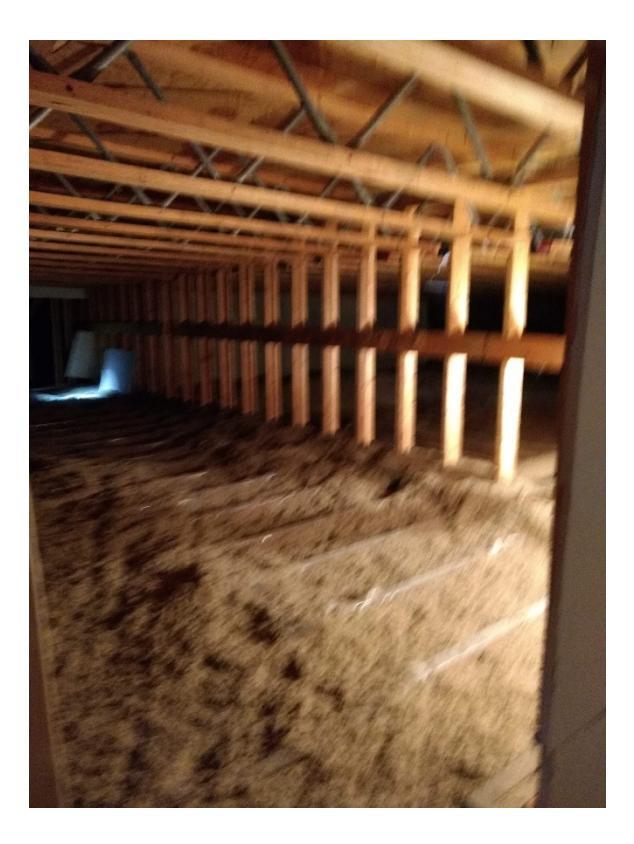
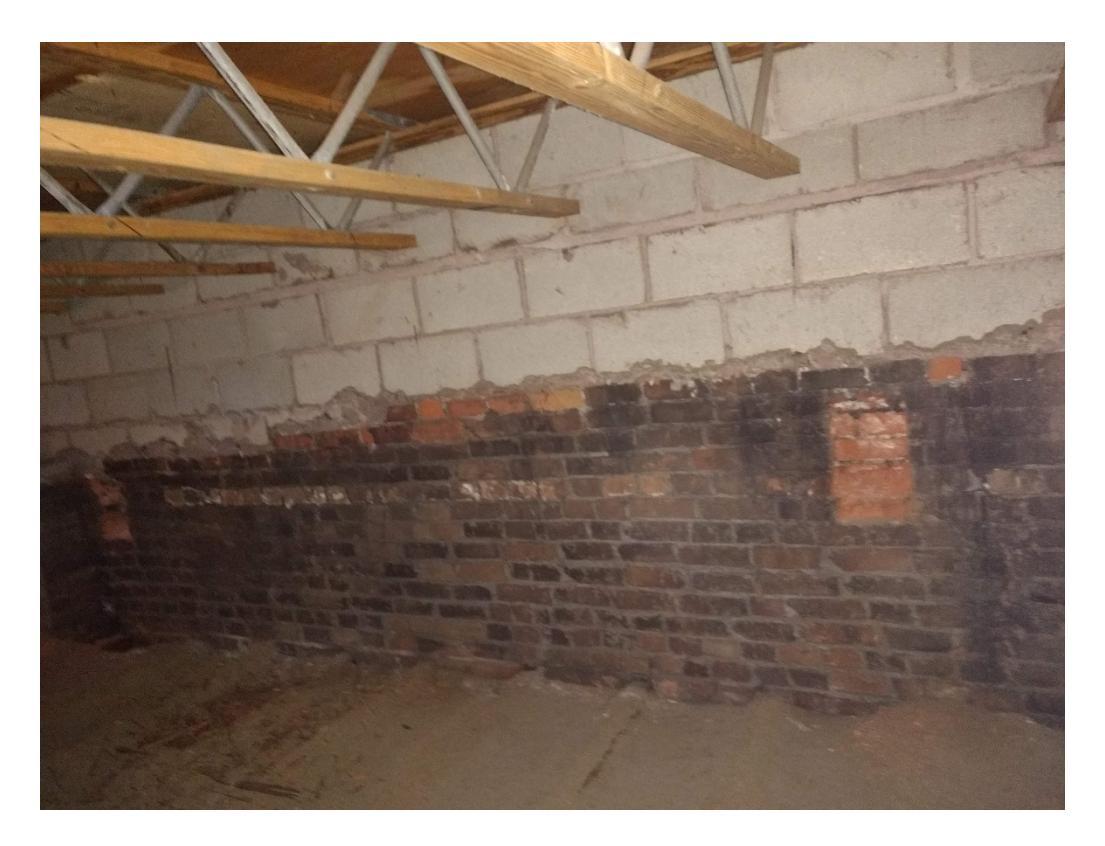
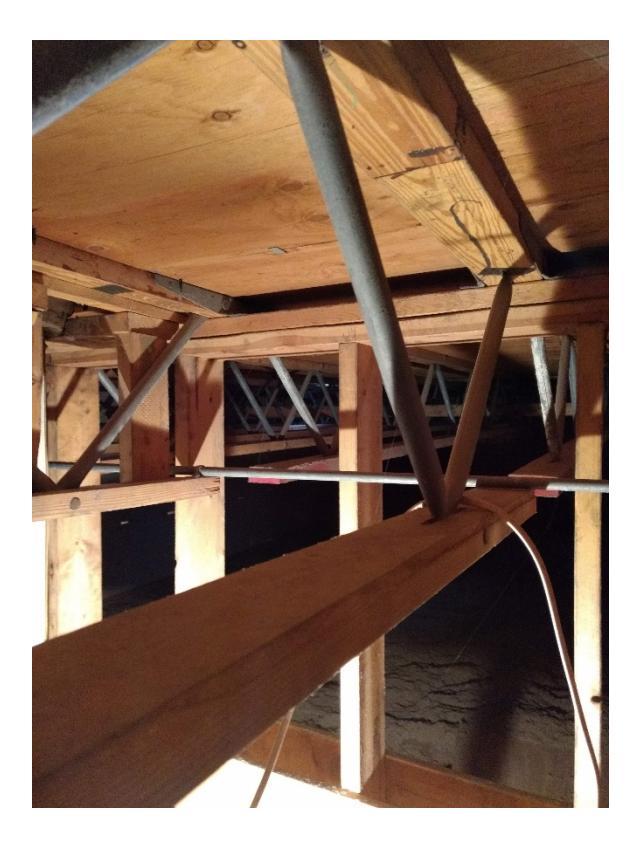
The roof framing consists of wood/steel truss joists spaced at 16-inches on center that span east to west from exterior wall to exterior wall with 5/8-inch plywood decking. These are relatively new and in good condition.
